# Report on the Acceptance Air Leakage Testing of 8 Benson Place in Oxford, in compliance with ATTMA TSL1 (2010)

**Site address:** 8 Benson Place, Oxford OX2 6QH

| JALDAS5037/R3 |
| 15 <sup>th</sup> November 2014 |

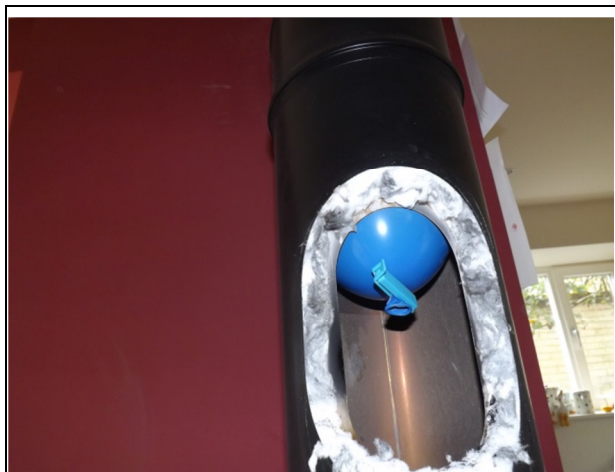
| <p>P4) Balloon used to temporarily seal flue from wood burning stove in the Living Room</p> | <p>P5) Temporary seal over end of incoming subfloor air duct for wood burning stove</p> |

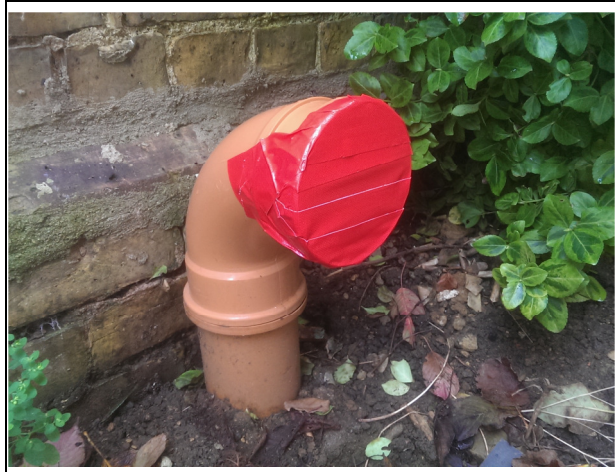
| <p>P6) Temporary seal over end of second incoming subfloor air duct for wood burning stove</p> | <p>P7) Temporary seal to inlet and outlet filters in Paul MVHR unit in loft to exclude leakage through the ventilation system</p> |

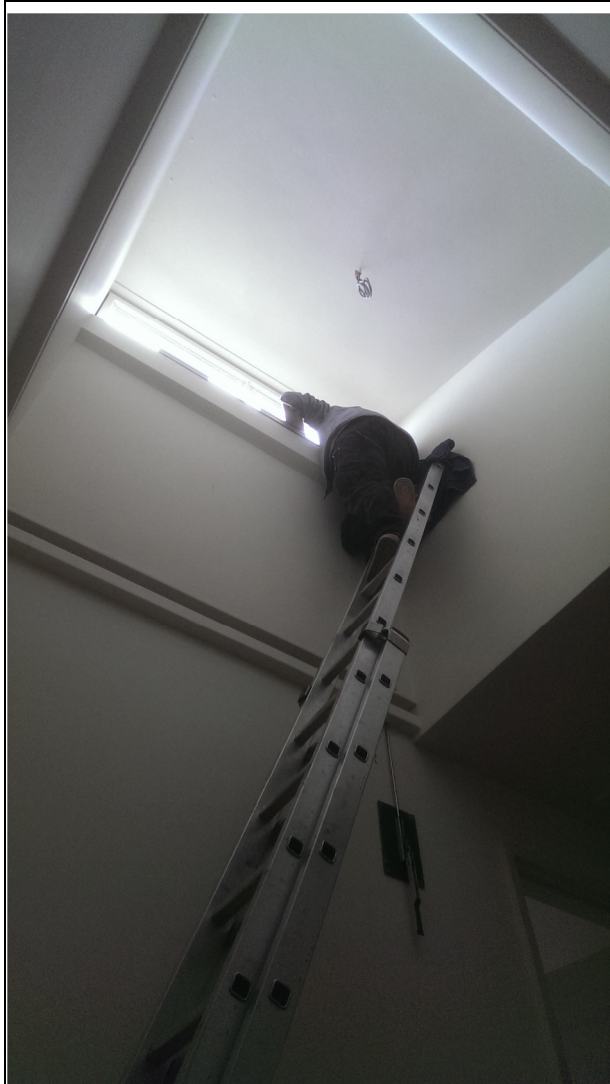
During the extensive leakage check, a number of major and minor leakage sites were identified, which are discussed later in this report. The most significant of these was adjusting the dormer window at the top of the stairwell to ensure it closed fully and sealed properly. A full multi-point depressurisation test was then carried out.

P8) Adjustments being made to dormer window and electric closer to achieve an effective seal. By far the most significant leak identified

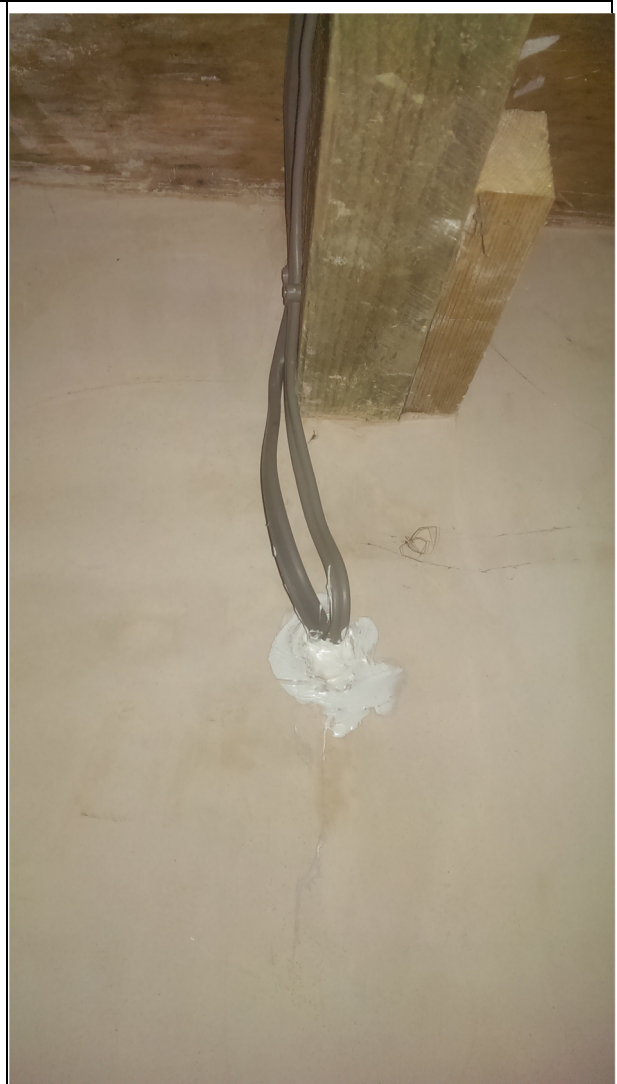
P9) Mastic seal around cable through wall to unheated outbuildings

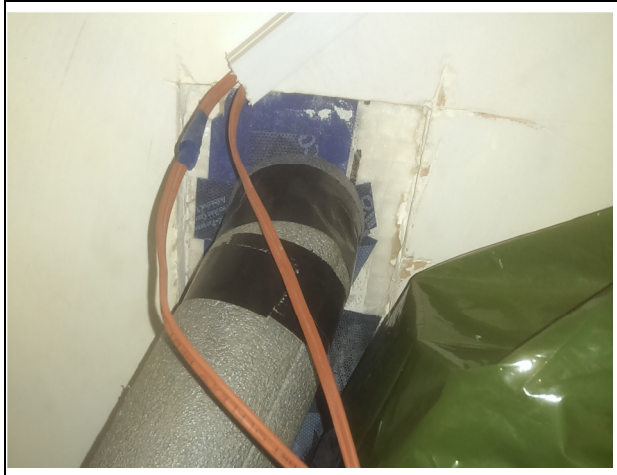
| <p>P10) Redone tape seal around pipe connection to solar thermal panel on roof</p> | <p>P11) Orcon-F mastic (green) having been used to seal leakage around cables and fixings through back of switch box – ideally would have been fully parged</p> |
