# Report on Pre-improvement Air Leakage Testing, in compliance with ATTMA TSL1 (2010)

**Result: Unsatisfactory**

**Site address:** 8 Benson Place, Oxford, OX2 6QH

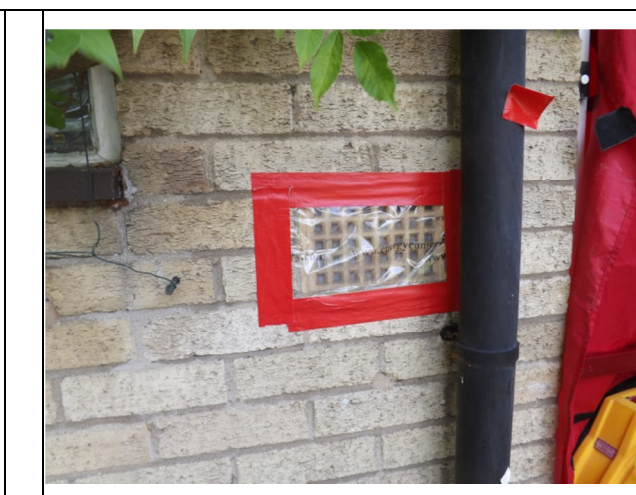
| <p>Fireplace in Living Room temporarily sealed with polythene and tape to prevent soot escaping into the room if dislodged</p> | <p>Airbrick to larder in kitchen temporarily sealed with polythene and tape externally – satisfactory because sleeved at time of cavity wall insulation, hence not open to cavity</p> |

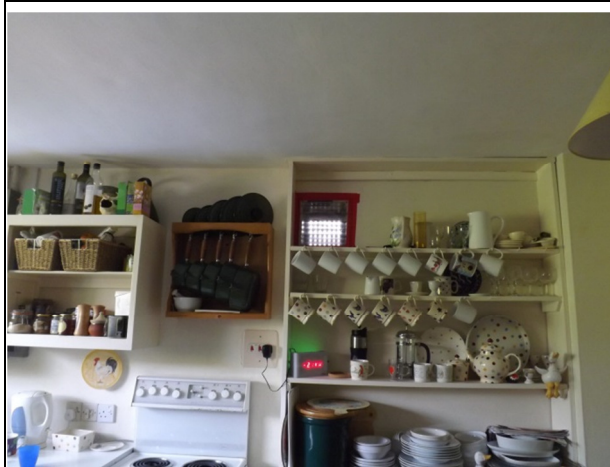
Airbrick in kitchen, largely sealed by resident, temporarily sealed for the test

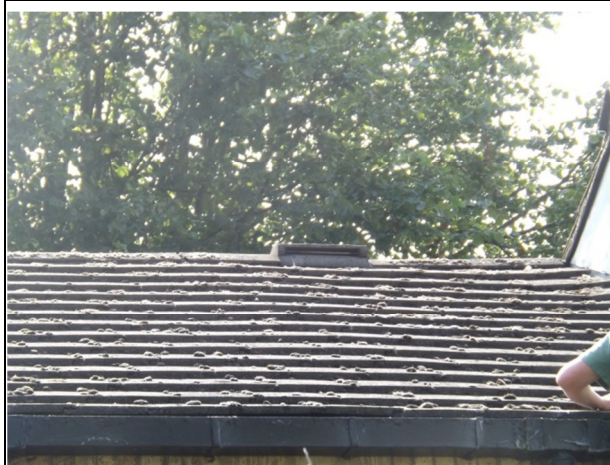
Open ridge vent from original heating to next door making co-pressure testing problematic

This was carried out at Benson Place, but hit a major snag in that the next door house was found to be so leaky that it was not initially possible to achieve the required pressure differential. After sealing off some airbricks with little impact, this was ultimately traced to an old heating system, which included a ridge vent that was still open to atmosphere. This was then temporarily sealed at which point the co-pressure testing could proceed.

Temporary sealing of ridge vent to facilitate co-pressure testing

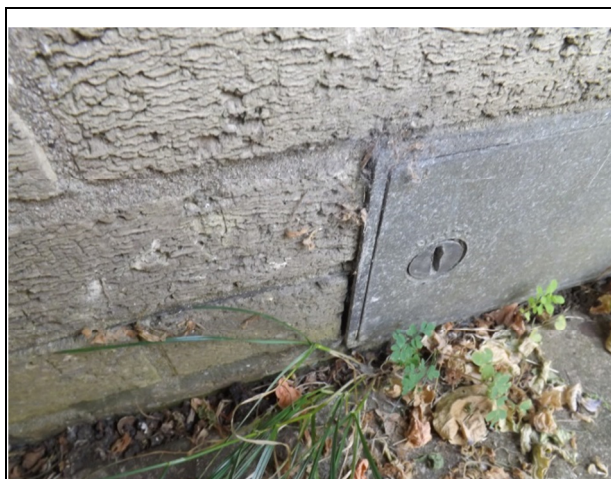
Leakage through gaps around access hatch at base of front wall

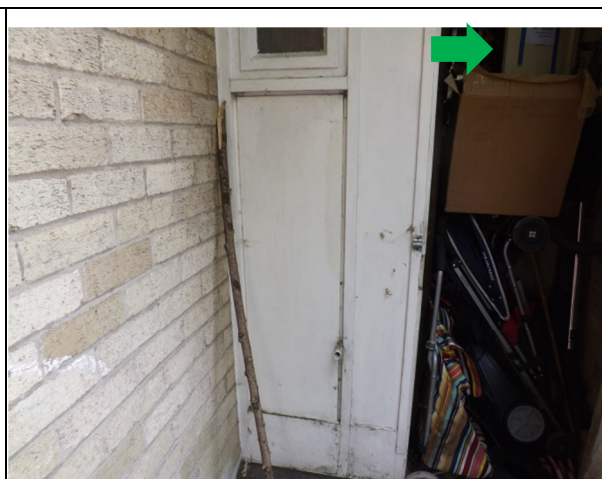
Substantial leakage at top of wall to external storage cupboard from downstairs WC

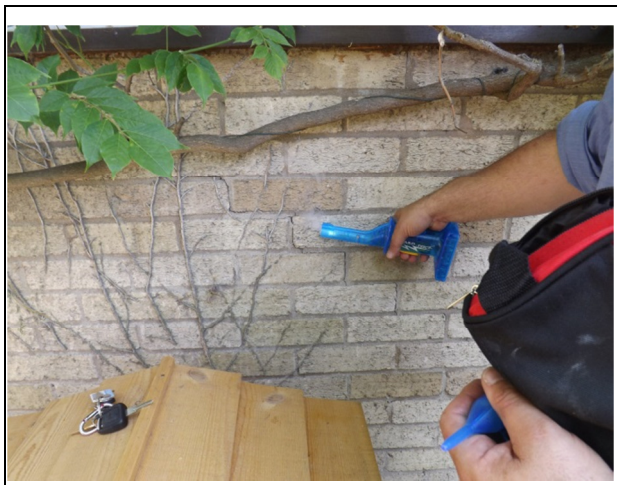
| <p>Using smoke to check for leakage through cracks in external wall beneath kitchen window. Also leakage found beneath edge of window sill</p> | <p>Checking for leakage at corner of window frame and beneath lintel above window</p> |
