# Report on the Acceptance Air Leakage Testing of 8 Benson Place in Oxford, in compliance with ATTMA TSL1 (2010)

**Site address:** 8 Benson Place, Oxford OX2 6QH

| JALDAS5037/R3 |
| 15 <sup>th</sup> November 2014 |

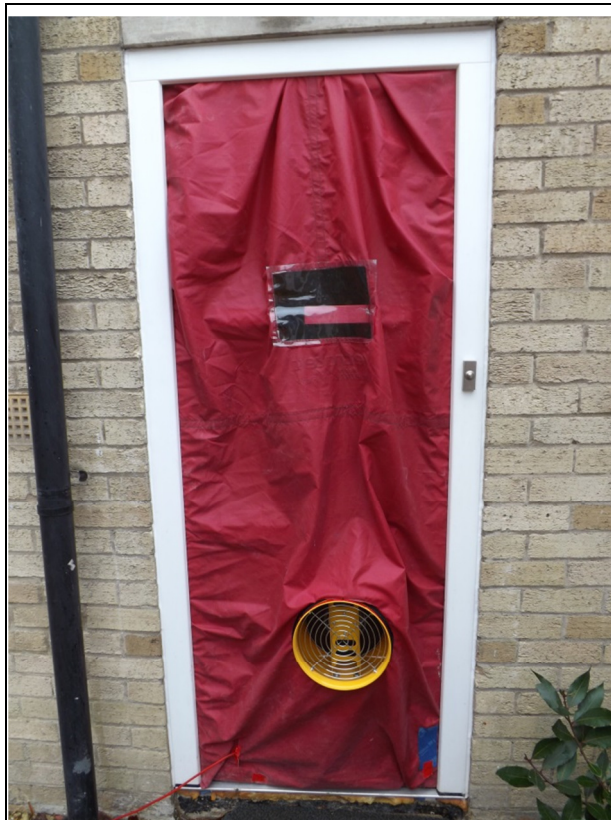
P2) External view of test equipment mounted in front entrance doorway

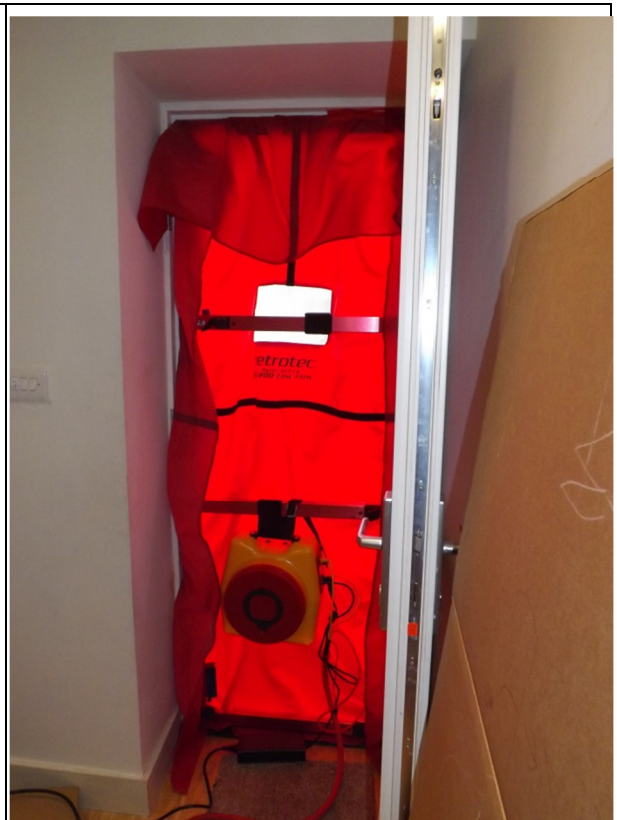
P3) Internal view of test equipment mounted in front entrance doorway

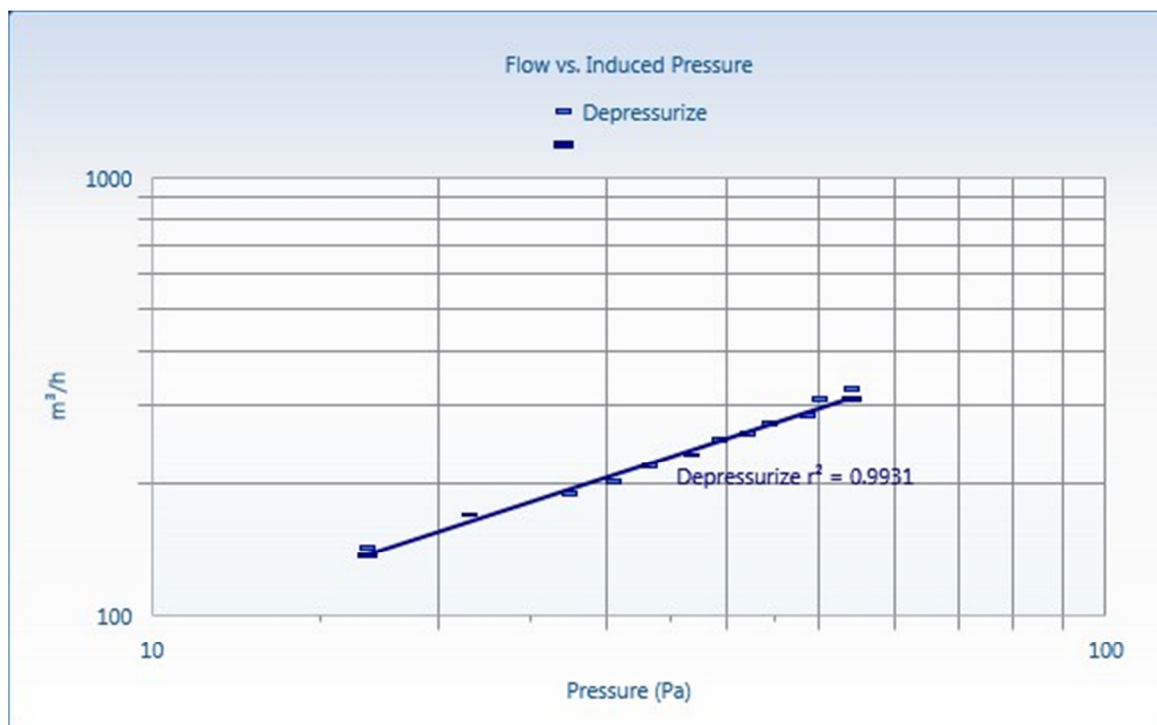
**G2: Graph of imposed pressure differential against airflow, Depressurize:**

| Depressurize Test Results | | | | | |
|---|---|---|---|---|---|
| Slope, $n$ | <b>0.70</b> | <b>0.64</b> | <b>0.76</b> | Equivalent leakage area at 50 Pa [cm²] | <b>148</b> <b>+/-2.8%</b> |

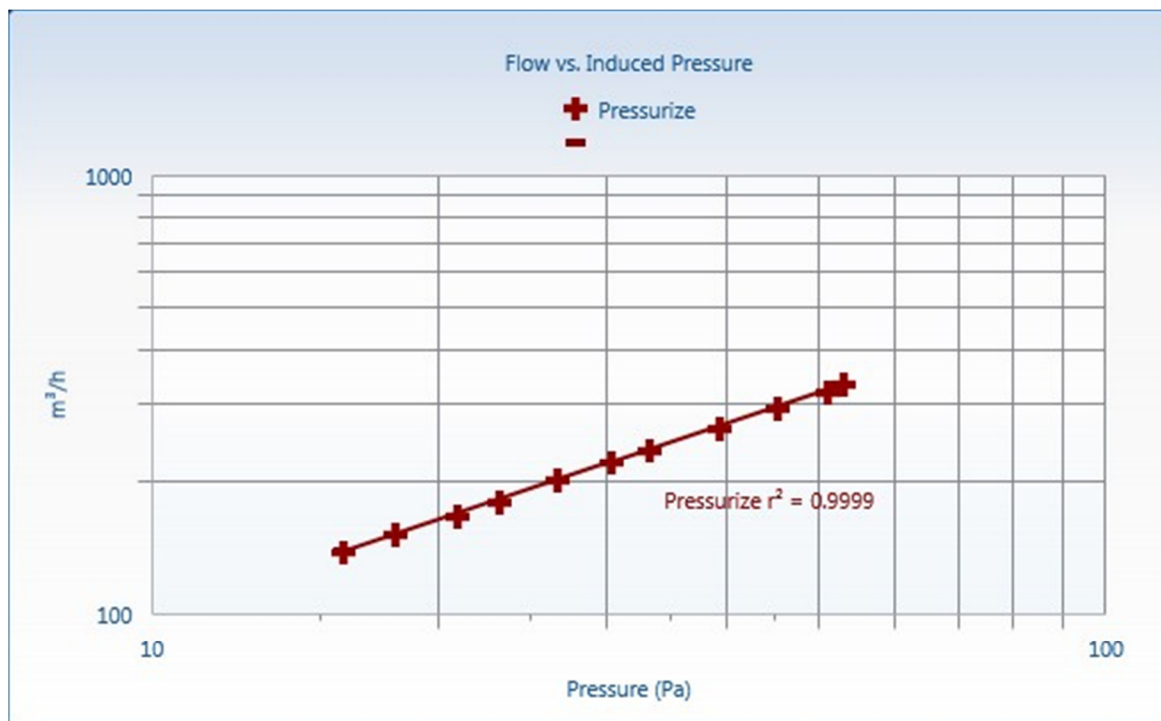
**G4: Graph of imposed pressure differential against airflow, Pressurize:**

| Pressurize Test Results | | | | | | |
|---|---|---|---|---|---|---|
| Slope, $n$ | 0.73 | 0.72 | 0.74 | Equivalent leakage area at 50 Pa [cm <sup>2</sup> ] | 160 | +/-0.6% |
